## **MOVING MOUNTAINS: A Mid-Year Look at Our Progress**

### **Mid-Year Update: A Turning Point for DeBerry WSC**

# **DeBerry WSC Mid-Year Update**

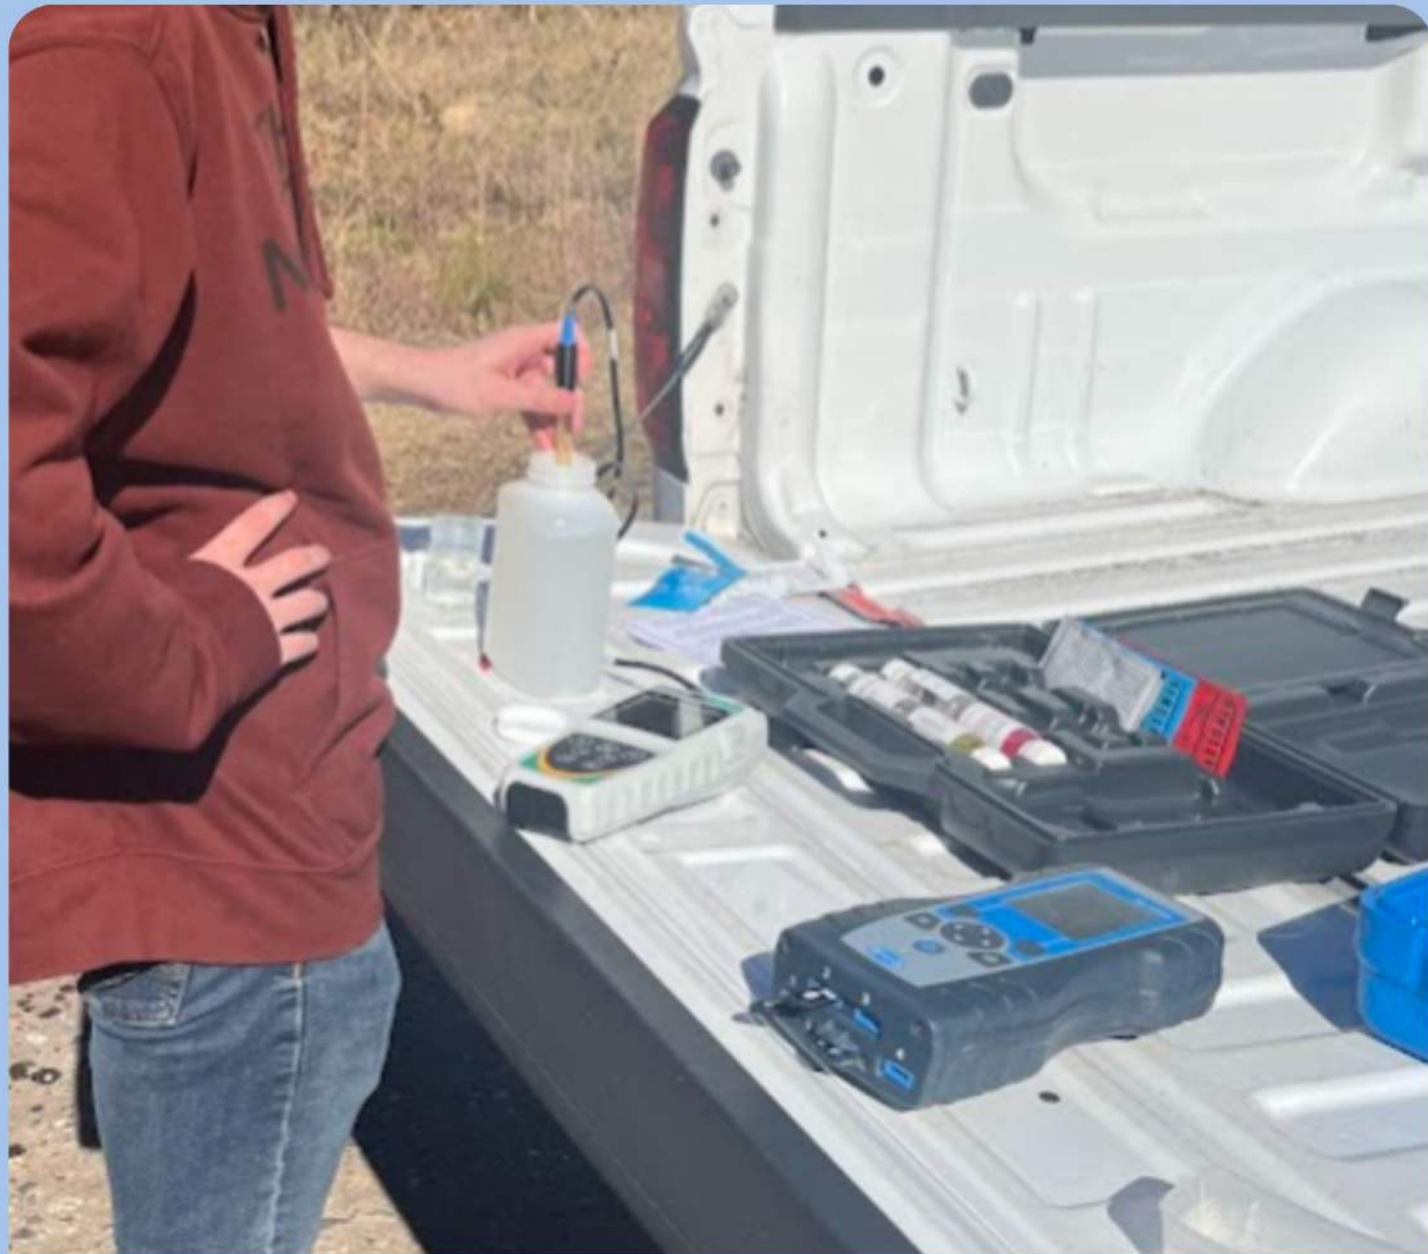
Our Operators Goal is  
to be able to call  
Heads or Tails at each  
site flushed

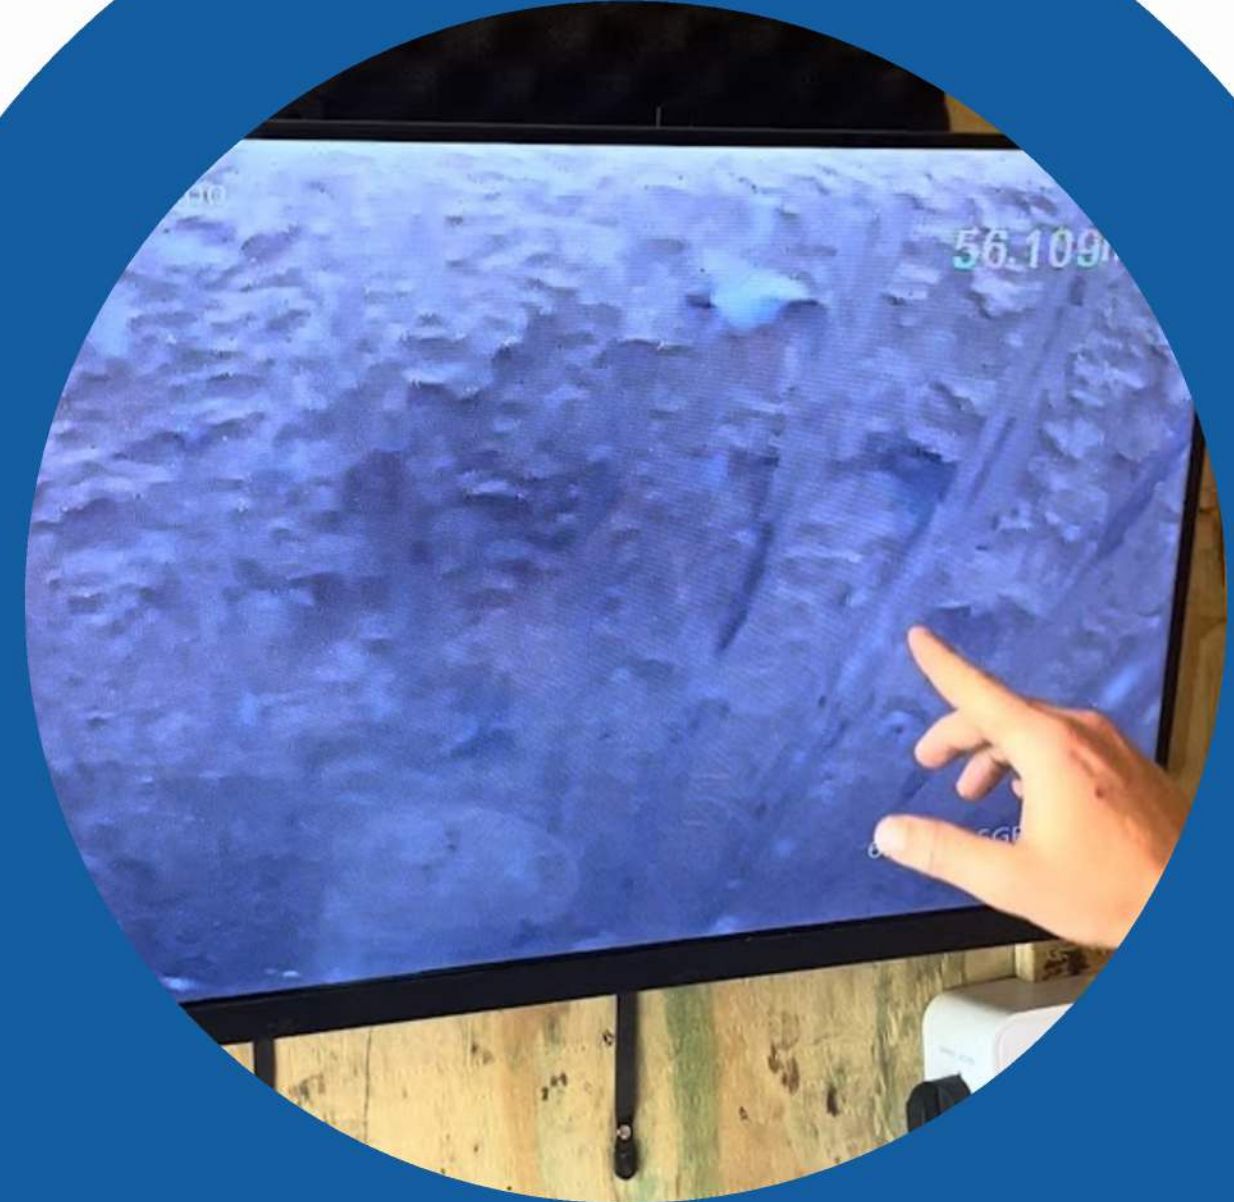
**Well #2 cleaned and rehabilitated.**

**Electrical upgrades made and more in progress. New pump and motor**

**Well #4 cleaned and video inspected for future rehab. New pump and motor**

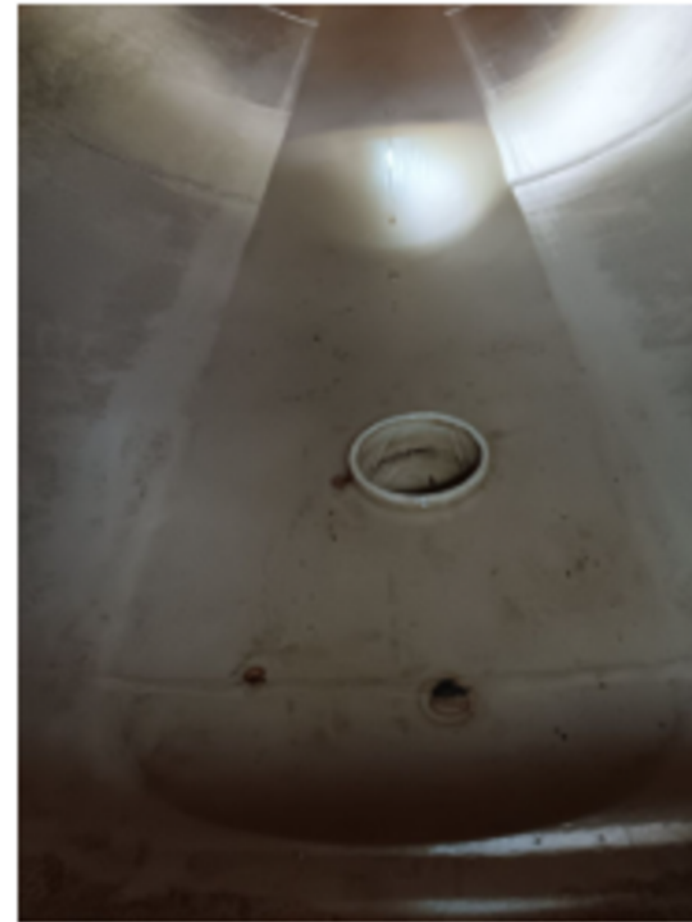
**In 2025, all storage and pressure tanks were fully drained and cleaned. Before this, some tanks had accumulated sediment that was unknowingly being pumped back into the distribution system. We have since implemented an annual inspection schedule, along with periodic spot checks, to ensure ongoing cleanliness and system integrity.**

*Pressure Tanks After Cleaning*

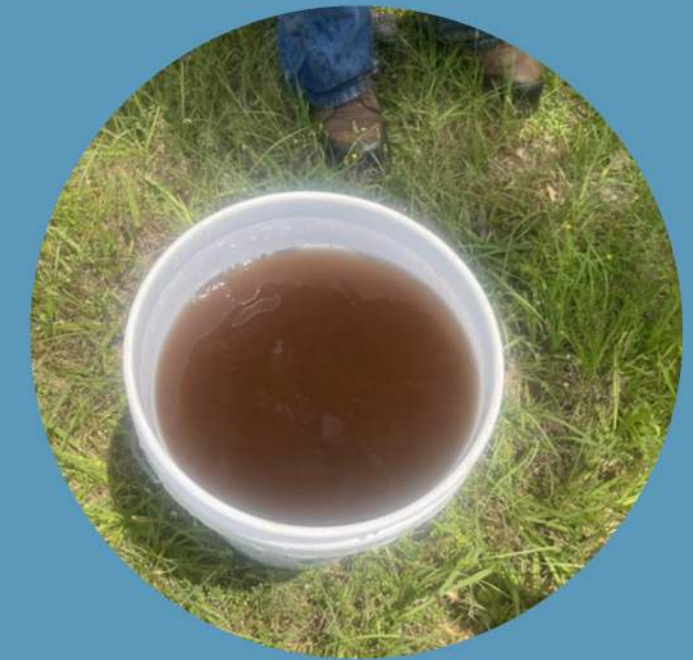
**We continue to find water lines that were undocumented or long forgotten. For years, I experienced poor water quality at my own home, with no amount of flushing providing a solution. Just last month, during a line break, the Colemans took it upon themselves to investigate further and discovered a dead-end line on my property—something no one had known about in recent memory. These are the types of challenges our field operators encounter daily, and they remain committed to uncovering and resolving them with diligence and care.**

**My personal line 4  
weeks ago**
